Manhole Inspection Summary

Manhole # S29GG1007MH

Insp Date: **1/4/07 9:36 AM**

Location Address: **531 40TH ST**

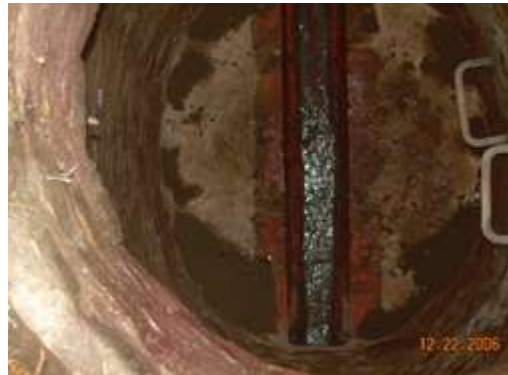
Top View

Bench debris.

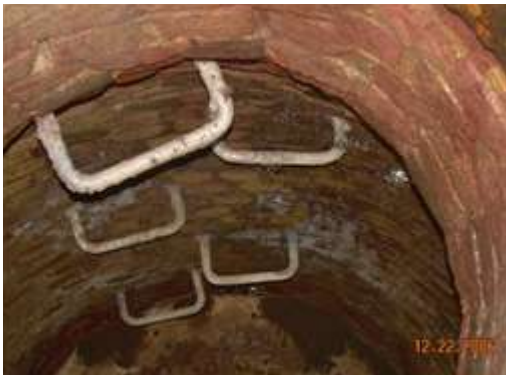
Defect

Frame leaks. Adjustment, Corbel and Barrel infiltration.

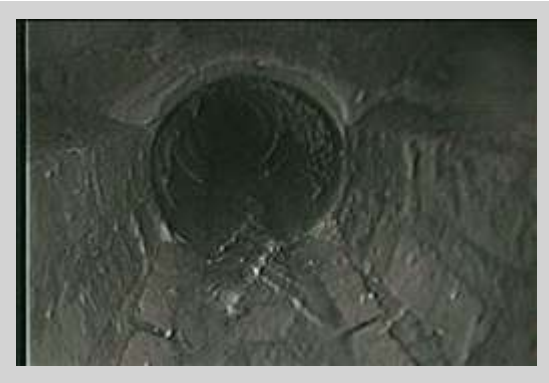
8 in. Circular Gravity Sewer Pipe Out @ 12 O'Clock

Infiltration: **Evidence** Pipe Seal Cond: **Unknown**

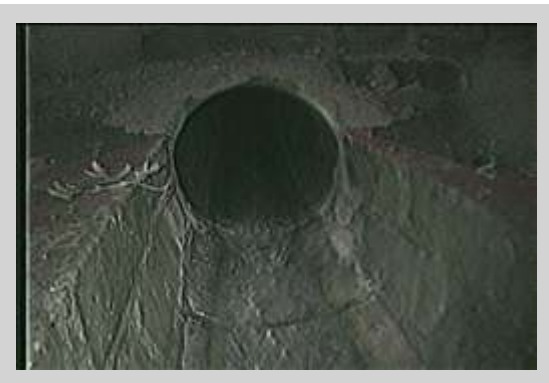
8 in. Circular Gravity Sewer Pipe In @ 6 O'Clock

Infiltration: **Evidence** Pipe Seal Cond: **Unknown**
